FEBRUARY 2026

LIVELIHOOD PAPS VERIFICATION STATUS REPORT

PREPARED BY G3
ENGINEERING
CONSULTANTS

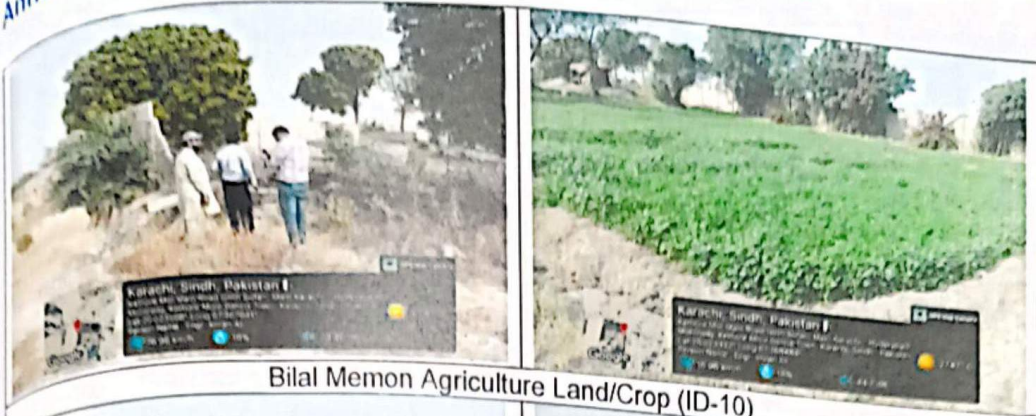
Bilal Memon Agriculture Land/Crop (ID-10)

ID No.	Owner Name	Longitude	Latitude	Type of structure	Name of Village	Land Fall in 300	Land Fall in 1000	Damages Status	Remarks	Amount
ID 10	Bilal Memon	25121.03	672154.04	Agriculture	UC-3 Gadap	Yes		Fully Damage	could not be traced. If identification remains unsuccessful after several attempts, then a formal request should be submitted to the Revenue Department for assistance in identifying the affected P.A.P.s. The cropped land has been fully damaged and eligible for the compensation according to NESPAK estimated calculation.	3275000
ID 11	Roshan Shaikh (Owner is Sohail)	25121.76	672128.71	Agriculture	Hina Society	Yes		Fully Damage	The cropped land has been fully damaged and eligible for the compensation according to NESPAK estimated calculation.	875000

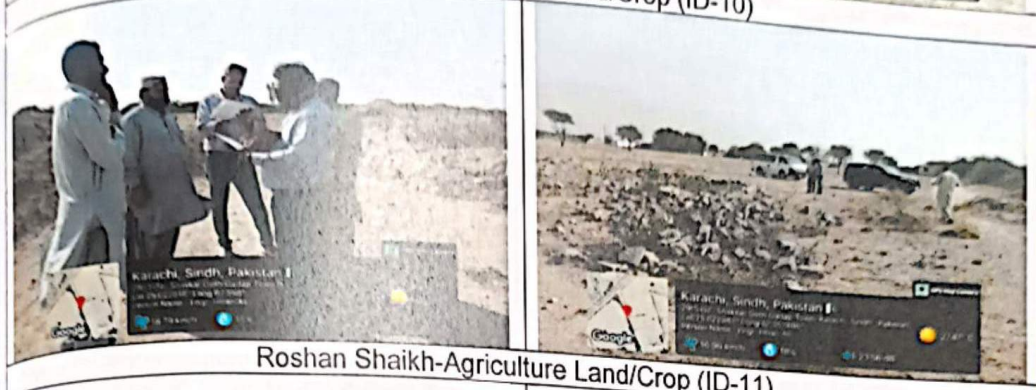
Roshan Shaikh-Agriculture Land/Crop (ID-11)

ID No.	Owner Name	Longitude	Latitude	Type of structure	Name of Village	Land Fall in 300	Land Fall in 1000	Damages Status	Remarks	Amount
ID 18	Roshan Shaikh (Sohail Shaikh owner)	25 1 21.76	67 21 28.71	Residential	Hina Society		Yes	Partially Damage	recommended that the Deputy Commissioner, Malir, be formally approached to assist in tracing and identifying the lawful owner of the property and to share the relevant details with the Project Director, CAP-RU, for further necessary action	1121400
ID 41	Nisar Ahmed	24.926431°	67.44331°	Residential	Dodo Salar Jokhio	Yes		Fully Damage	The structure is located within 1,000 feet strip and found boundary wall, sheds room, and water tank have been damaged by the KIV activities. This case was not included into the CAP report by NESPAK.	1045146

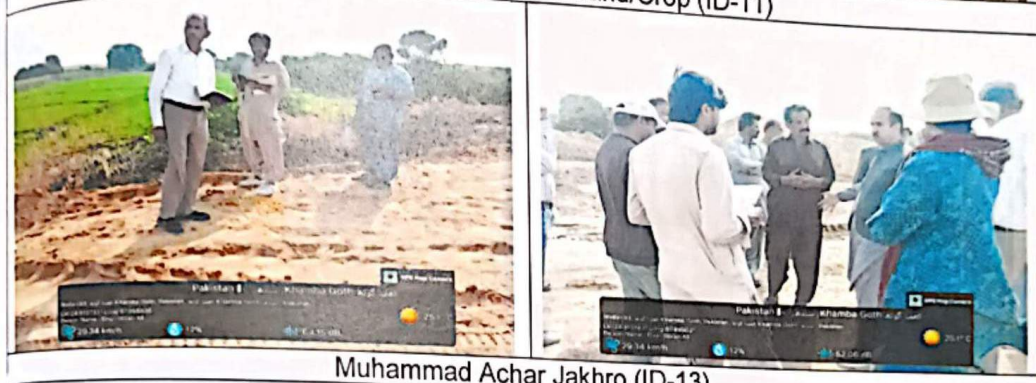
Muhammad Achar Jakhro (ID-13)

ID No.	Owner Name	Longitude	Latitude	Type of structure	Name of Village	Land Fall in 300	Land Fall in 1000	Damages Status	Remarks	Amount
ID 13	Muhammad Achar Jakhro.	24.910693	67.99877	Agriculture	Achar Jakhro Village Thatta	Yes		Fully Damage	This land is located within the 300-foot project ROW and was completely damaged.	300000
ID 19	Mehboob Brohi	24.900232	67.9862	Residential	Gul Muhammad Brohi, Thatta	Yes		Fully Damaged	The structure is fully damaged and eligible for compensation accordingly. This falls within 300 feet.	1740000
ID 14	Gul Muhammad Brohi	24.90012	67.986469	Agriculture	Gul Muhammad Brohi Village	Yes		Fully Damage	It lies within 300 feet. The owner said that land has been fully damaged due to NOV construction activity and	1275000

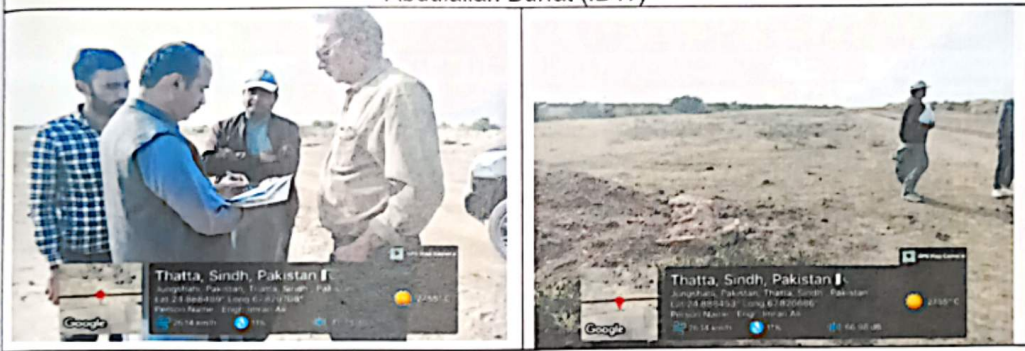
Abdul Wahid (ID18)

ID No.	Owner Name	Longitude	Latitude	Type of structure	Name of Village	Land Fall in 300	Land Fall in 1000	Damages Status	Remarks	Amount
ID 18	Abdul Wahid	24.888661	67.821097	Agriculture	Allah Bachiyoh Goth	Yes		Fully Damage	It lies within 300 feet. The owner told that land has been fully damaged due to KIV construction activity and eligible for compensation accordingly.	2275000
ID 20	Wahid buksh	25 4 11.37	67 12 33.15	Residential	Muhammad Yousuf Sahlari Goth	Yes		Fully Damage	It falls within 300 feet, and the structure has been fully damaged and eligible for the compensation.	479000
ID 04	Sohail Anwar	25 4 43.68	67 11 59.01	Employment	Near Abdul Raheem Khaskheli	Yes		Fully Damage	This property is located within the 300-foot ROW. One employee Mr. Gohar Lashari is available while other four employees have left the farmhouse and are now employed in another	150000

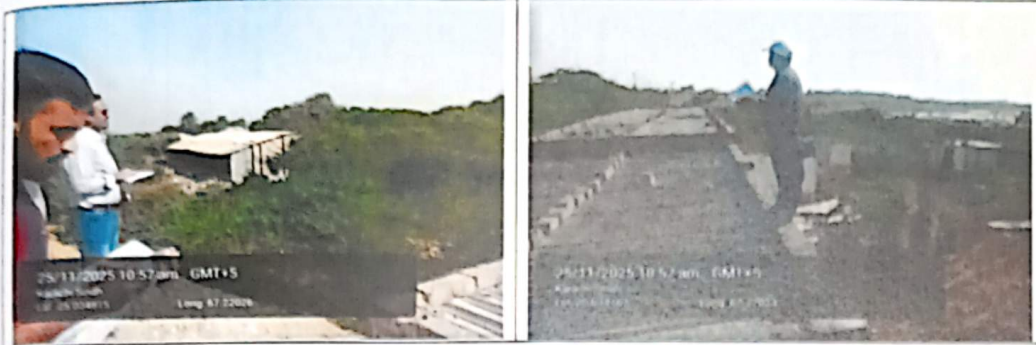
Absentee Owner (ID-28 and 29)

ID No.	Owner Name	Longitude	Latitude	Type of structure	Name of Village	Land Fall in 300	Land Fall in 1000	Damages Status	Remarks	Amount
ID 28	Absentee owner	25 2 30.70	67 13 53.42	Residential	Khaskheli Goth	Yes		Fully Damage	The structure is located within the 300-foot project corridor and has sustained complete damage. The owner was not present at the site, and despite several visits, the verification team was unable to establish contact. It is therefore recommended that the Deputy Commissioner, Malir, be formally approached to assist in tracing and identifying the lawful owner of the property and to share the relevant details with the	431,600

ID No.	Owner Name	Longitude	Latitude	Type of structure	Name of Village	Land Fall in 300	Land Fall in 1000	Damages Status	Remarks	Amount
ID 29	Absentee owner	25 2 11.94	67 14 22.27	Residential	Near Khaskheli Goth	Yes		Fully Damage	The structure is located within the 300-foot project corridor and has sustained complete damage. The owner was not present at the site, and despite several visits, the verification team was unable to establish contact. It is therefore recommended that the Deputy Commissioner, Malir, be formally approached to assist.	641000

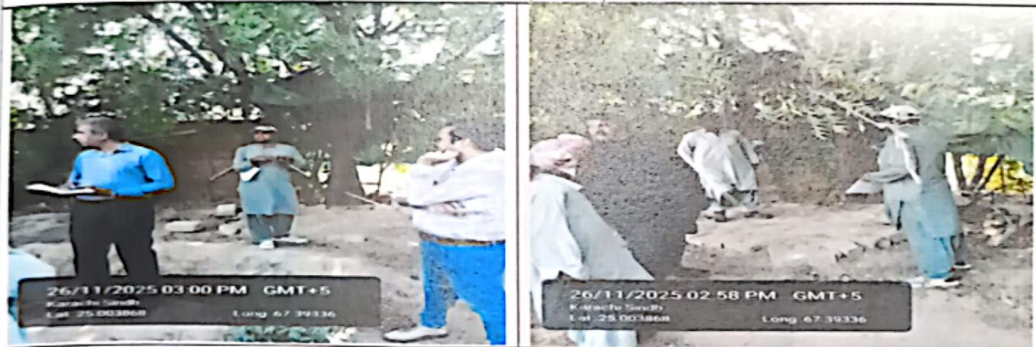
Jan Muhammad Baloch (ID-16)

ID No.	Owner Name	Longitude	Latitude	Type of structure	Name of Village	Land Fall in 300	Land Fall in 1000	Damages Status	Remarks	Amount
ID 16	Jan Mohammad Baloch	24.59 40.79	67.23 20.48	Residential	Mola Bux Baloch Goth		Yes	Partially Damage	According to NESPAK survey, it was mentioned that rooms, boundary wall, kitchen and washrooms to be potentially damaged. According to findings of LVC, only boundary wall is partially damaged by K-IV construction activities. This boundary wall falls within the 1,000-foot zone, not the 300-foot zone. This case should be paid only for the partially boundary damage.	613800
ID 09	Absentee Owner	24.52 28.94	67.45 32.40	Commercial	Juman Khan Jokhio	Yes		Partially Damage	The structure is located within the 300-foot project corridor and has sustained complete damage. The owner was not present at the site, and despite several visits, the verification team was unable to establish contact. It is therefore recommended that the Deputy Commissioner, Malir, be formally approached to assist in	6892000

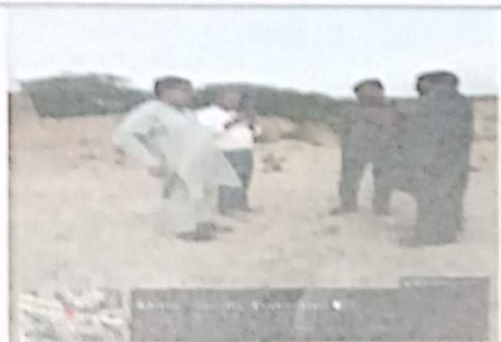
Arshad (ID-42)

ID No.	Owner Name	Longitude	Latitude	Type of structure	Name of Village	Land Fall in 300	Land Fall in 1000	Damages Status	Remarks	Amount
ID 42	Arshad Khan Jokhio	24.926431°	67.44331°	Residential	Dodo Salar Jokhio	Yes		Fully Damage	however, this person approached the LVC during field visit and requested for inclusion of his structure which was missing. The LVC further conducted physical survey of the structure and it was found that structure was fully damaged in 300-foot ROW. This case is recommended to be eligible for the compensation. This case was not included in the CAP report by NESPAK, however, this person approached the LVC during field visit and requested for inclusion of his	1045146

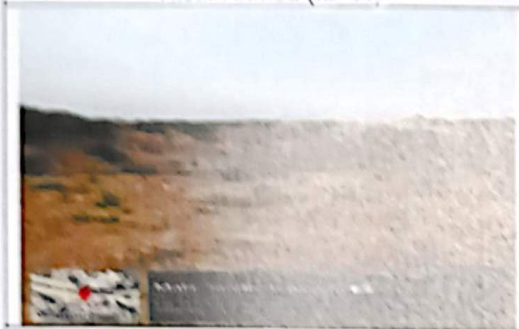
Muhammad Rahim (ID-43)

ID No.	Owner Name	Longitude	Latitude	Type of structure	Name of Village	Land Fall in 300	Land Fall in 1000	Damages Status	Remarks	Amount
ID 43	Muhammad Rahim	24.926431°	67.44331°	Residential	Dodo Salar Jokhio	Yes		Fully Damage	structure which was missed. The LVC further conducted physical survey of the structure and it was found that structure was fully damaged in 300-foot ROW. This case is recommended to be eligible for the compensation. This case was not included in the CAP report by NESPAK, however, this person approached the LVC during field visit and requested for inclusion of his structure which was missed. The LVC further conducted physical survey of the	1045146

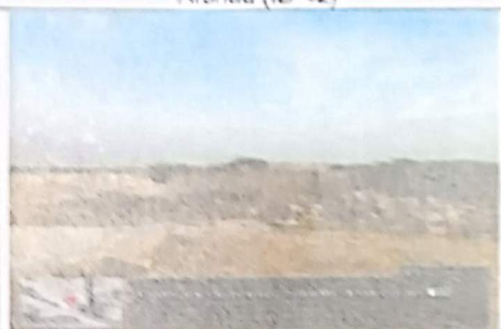
Javed (ID-44)

ID No.	Owner Name	Longitude	Latitude	Type of structure	Name of Village	Land Fall in 300	Land Fall in 1000	Damages Status	Remarks	Amount
ID 44	Javed Khan	24.926431°	67.44331°	Residential	Dodo Salar Jokhio	Yes		Fully Damage	structure and it was found that structure was fully damaged in 300-foot ROW. This case is recommended to be eligible for the compensation. This case was not included in the CAP report by NESPAK, however, this person approached the LVC during field visit and requested for inclusion of his structure which was missed. The LVC further conducted physical survey of the structure and it was found that structure was fully damaged in 300-foot ROW. This case is	1045146

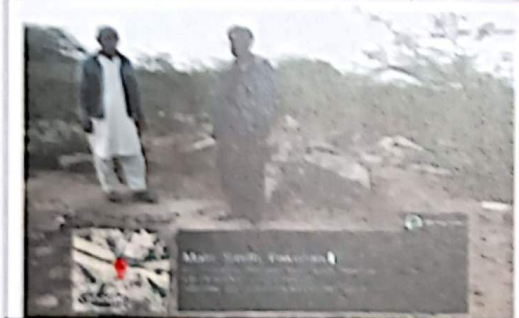
Muhammad Hanif (ID-45)

ID No.	Owner Name	Longitude	Latitude	Type of structure	Name of Village	Land Fall in 300	Land Fall in 1000	Damages Status	Remarks	Amount
ID 45	Muhammad Hanif	24.926431°	67.44331°	Residential	Dodo Salar Jokhio	Yes		Fully Damage	This case was not included in the CAP report by NESPAK, however, this person approached the LVC during field visit and requested for inclusion of his structure which was missed. The LVC further conducted physical survey of the structure and it was found that structure was fully damaged in 300-foot ROW. This case is recommended to be eligible	1045146

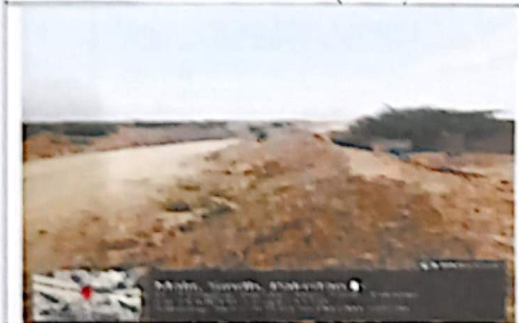
Saindad (ID-47)

ID No.	Owner Name	Longitude	Latitude	Type of structure	Name of Village	Land Fall in 300	Land Fall in 1000	Damages Status	Remarks	Amount
ID 47	Sain dad	24.926431°	67.44331°	Residential	Dodo Salar Jokhio	Yes		Fully Damage	This case was not included in the CAP report by NESPAK, however, this person approached the LVC during field visit and requested for inclusion of his structure which was missed. The LVC further conducted physical survey of the structure and it was found that structure was fully damaged in 300-foot ROW. This case is recommended to be eligible for the compensation.	1045145
ID 48	Ali Asghar	24.926431°	67.44331°	Residential	Dodo Salar Jokhio	Yes		Fully Damage	This case was not included in the CAP report by NESPAK, however, this person approached	1045145

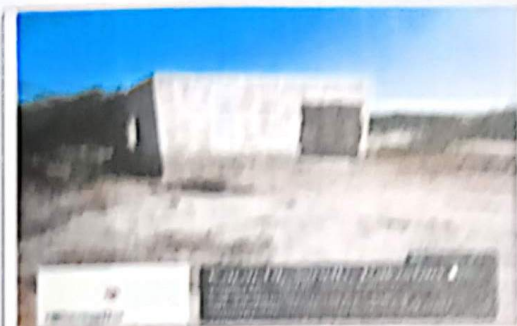
Muhammad Yousef (ID-49)

ID No.	Owner Name	Longitude	Latitude	Type of structure	Name of Village	Land Fall in 300	Land Fall in 1000	Damages Status	Remarks	Amount
	Muhammad Yousof	24.988801	67.211629	Residential	Yousuf Sathni Goth	Yes		Fully Damage	the LVC during field visit and requested for inclusion of his structure which was missing. The LVC further conducted physical survey of the structure, and it was found that structure was fully damaged in 300-foot ROW. This case is recommended to be eligible for the compensation. This case was not included in the CAP report by NESPAK, however, this person approached the LVC during field visit and requested for inclusion of his structure which was missed. The LVC	903000

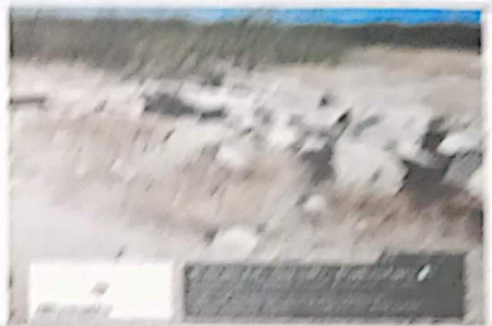
Abdul Hameed (ID-50)

ID No.	Owner Name	Longitude	Latitude	Type of structure	Name of Village	Land Fall in 300	Land Fall in 1000	Damages Status	Remarks	Amount
ID 50	Abdul Haroon Assistant Commissioner Sulthanpur Division District Mairathalli	24.988801	67.211629	Residential	Yousuf Sathni Goth	Yes		Fully Damage	further conducted physical survey of the structure and it was found that structure was fully damaged in 300-foot ROW. This case is recommended to be eligible for the compensation. This case was not included in the CAP report by NESPAK, however, this person approached the LVC during field visit and requested for inclusion of his structure which was missed. The LVC further conducted physical survey of the structure and it was found that structure was	903000

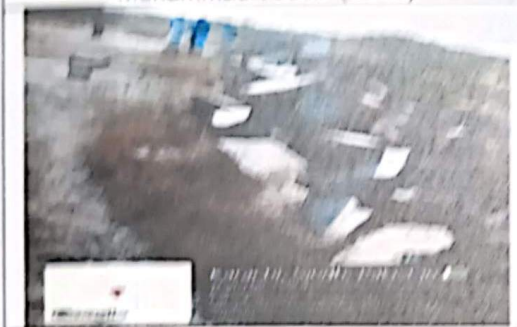
Ehabibuz (ID-51)

ID No.	Owner Name	Longitude	Latitude	Type of structure	Name of Village	Land Fall in 300	Land Fall in 1000	Damages Status	Remarks	Amount
ID 51	Elahi Bux	24.988801	67.211629	Residential	Yousuf Sathni Goth	Yes		Fully Damage	fully damaged in 300-foot ROW. This case is recommended to be eligible for the compensation. This case was not included in the CAP report by NESPAK, however, this person approached the LVC during field visit and requested for inclusion of his structure which was missed. The LVC further conducted physical survey of the structure and it was found that structure was fully damaged in 300-foot ROW. This case is recommended to be eligible	288500

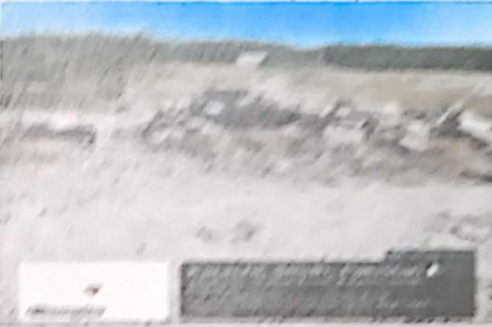
Amr (ID-52)

ID No.	Owner Name	Longitude	Latitude	Type of structure	Name of Village	Land Fall in 300	Land Fall in 1000	Damages Status	Remarks	Amount
ID 52	Muhammad Anwar	24.988801	67.211629	Residential	Yousuf Sathni Goth	Yes		Fully Damage	This case was not included in the CAP report by NESPAK, however, this person approached the LVC during field visit and requested for inclusion of his structure which was missed. The LVC further conducted physical survey of the structure and it was found that structure was fully damaged in 300-foot ROW. This case is recommended to be eligible for the compensation.	903000

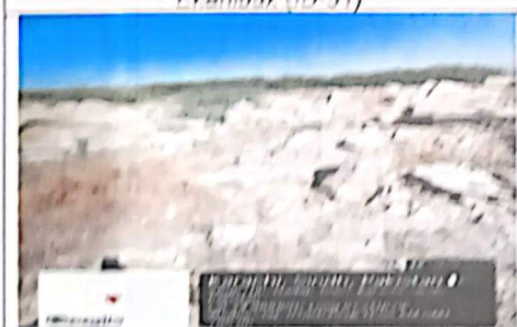
Abdul Ghafoor (ID-53)

ID No.	Owner Name	Longitude	Latitude	Type of structure	Name of Village	Land Fall in 300	Land Fall in 1000	Damages Status	Remarks	Amount
ID 53	Muhammad Soomer	24.988801	67.211629	Residential	Yousuf Sathni Goth	Yes		Fully Damage	This case was not included in the CAP report by NESPAK, however, this person approached the LVC during field visit and requested for inclusion of his structure which was missed. The LVC further conducted physical survey of the structure and it was found that structure was fully damaged in 300-foot ROW. This case is recommended to be eligible for the compensation.	288500
ID 54	Abdul Hassan	24.988801	67.211629	Residential	Yousuf Sathni Goth	Yes		Fully Damage	This case was not included in the CAP report by NESPAK, however, this person approached	288500

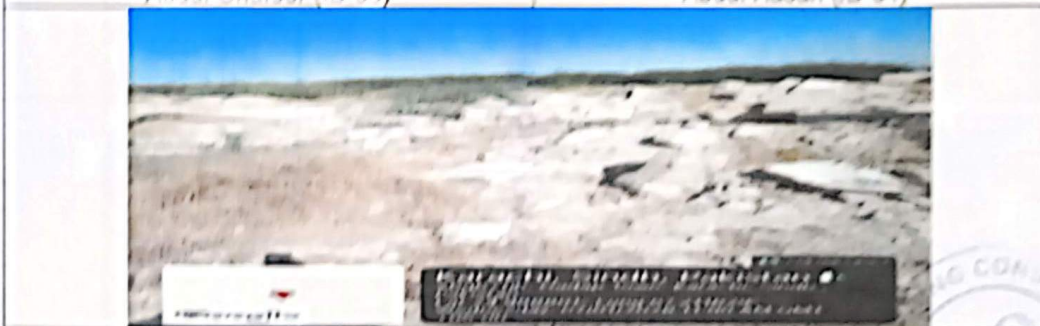
(ID-55)

ID No.	Owner Name	Longitude	Latitude	Type of structure	Name of Village	Land Fall in 300	Land Fall in 1000	Damages Status	Remarks	Amount
ID 55	Abdul Ghaffar	24.988801	67.211629	Residential	Yousuf Sathni Goth	Yes		Fully Damage	the LVC during field visit and requested for inclusion of his structure which was missed. The LVC further conducted physical survey of the structure and it was found that structure was fully damaged in 300-foot ROW. This case is recommended to be eligible for the compensation. This case was not included in the CAP report by NESPAK, however, this person approached the LVC during field visit and requested for inclusion of his structure which was missed. The LVC	283500

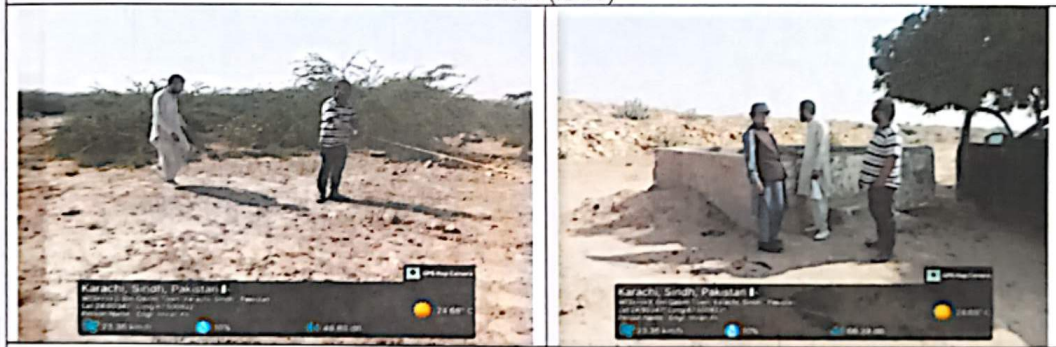
Absentee Owner (ID-8)

ID No.	Owner Name	Longitude	Latitude	Type of structure	Name of Village	Land Fall in 300	Land Fall in 1000	Damages Status	Remarks	Amount
ID 08	Absentee Owner	24 51 58	67 36 32	Commercial	Near Ran Pathani Wah, Thatta	Yes		Fully Damage	city/area. It is recommended that this case be reviewed by the Livelihood Committee to determine whether compensation should be provided or not. The poultry farm is located within the 300-foot zone and completely damaged. Despite multiple visits, the owner could not be contacted by the team. A proper stakeholder consultation held in nearby villages to identify absentee owners, however, owner's whereabouts	13456800

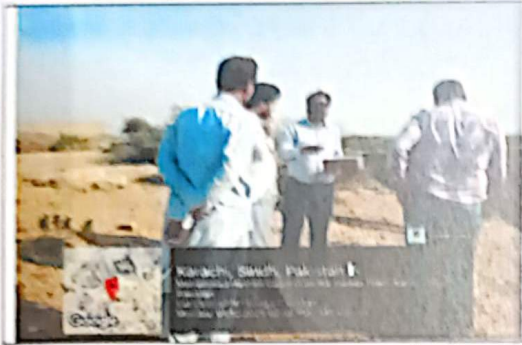
Rafique Gabol (ID-6)

ID No.	Owner Name	Longitude	Latitude	Type of structure	Name of Village	Land Fall in 300	Land Fall in 1000	Damages Status	Remarks	Amount
ID 06	Rafique Gabol	25 1 31.73	67 21 11.79	Commercial	Near Muhammad Hashim Gabol Goth		Yes	Fully Damage	The poultry farm is fully damaged in old alignment 1,000 feet and eligible for the compensation accordingly.	10754500
ID 12	Absentee Owner	24.903762	67.5006	Residential	Near Dargah Noor Shah			Fully Damage	The poultry farm is located within the 300-foot zone and completely damaged. Despite multiple visits, the owner could not be contacted by the team. A proper stakeholder consultation was held in nearby villages to identify absentee owners; however, owner's whereabouts could not be traced. If identification remains unsuccessful	1325742

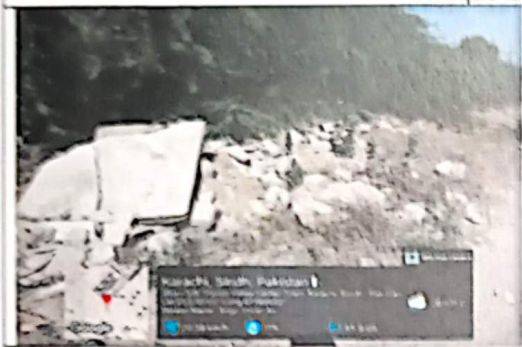
Absentee Owner (ID-16)

ID No.	Owner Name	Longitude	Latitude	Type of structure	Name of Village	Land Fall in 300	Land Fall in 1000	Damages Status	Remarks	Amount
ID 16	Absentee Owner	25 4 43.68	67 11 59.01	Commercial	Shah Mureed Goth	Yes		Fully Damage	The structure is located within the 300-foot project corridor and has sustained complete damage. The owner was not present at the site, and despite several visits, the verification team was unable to establish contact. It is therefore recommended that the Deputy Commissioner, Malir, be	446000

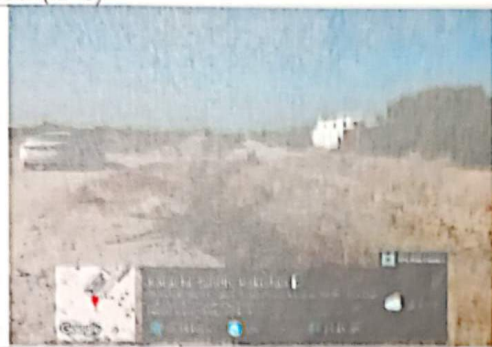
Absentee Owner (ID-17)

ID No.	Owner Name	Longitude	Latitude	Type of structure	Name of Village	Land Fall in 300	Land Fall in 1000	Damages Status	Remarks	Amount
ID 17	Absentee Owner	25 4 43.68	67 11 59.01	Commercial	Shah Mureed Goth	Yes		Fully Damaged	formally approached to assist in tracing and identifying the lawful owner of the property and to share the relevant details with the Project Director, CAP-RU, for further necessary action The structure is located within the 300-foot project corridor and has sustained complete damage. The owner was not present at the site, and despite several visits, the verification team was unable to establish contact. It is therefore recommended that the Deputy	2654800

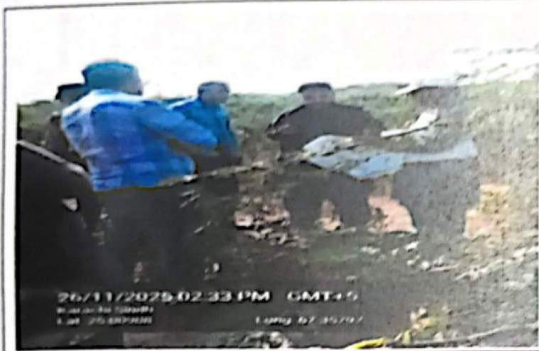
Prayer Place (ID-1)

Religious/Community: According to NESPAC CAP report, 4 mosques and 2 Prayer places are shown as damaged. However, validation found only 1 small mosque and 5 temporary prayer places with cemented floor. All these 6 structures are still available on site and not damaged. Moreover, field validation evident that these are not proper mosques and no mosque management committees were found or approached for compensation.
